Ditch Doings Winter, 2019-20

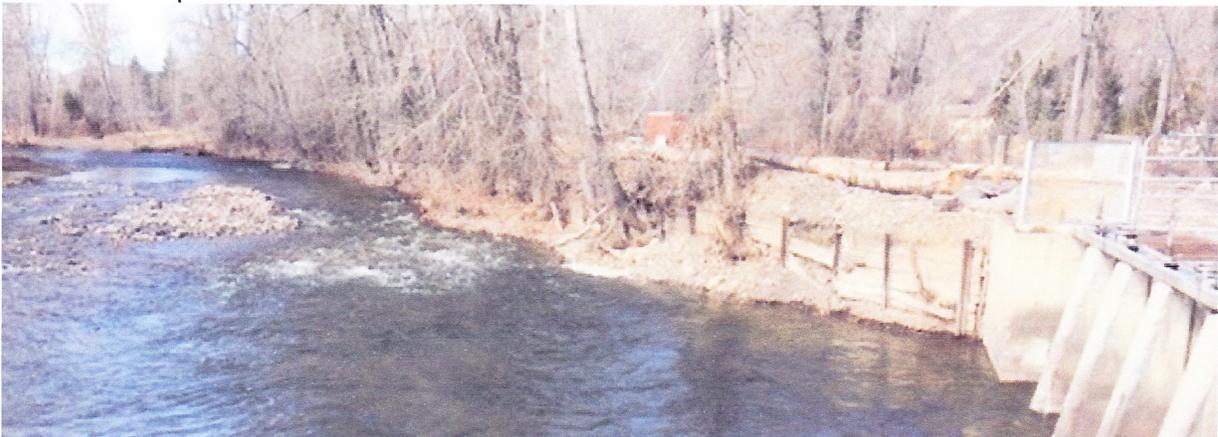
This is history! The 60 year old boards and steel are gone; the bank and trees are gone.

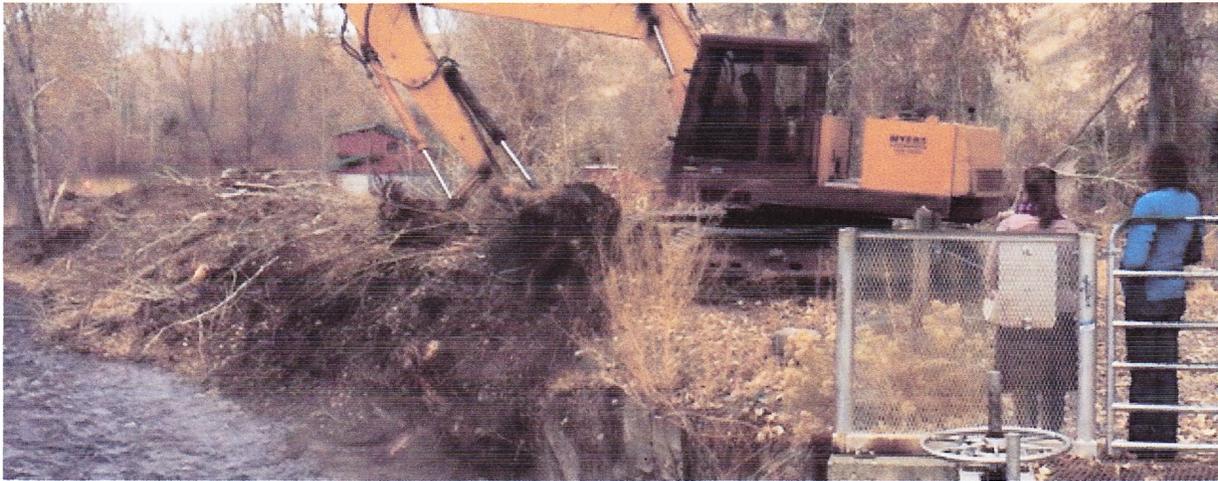
November 12 Our meeting, planning, and funding had been finished. The largest share of the expenses came from grants provided by the state and the local flood district for the purpose of mitigating future flood damage. This was determined to be a vulnerable length of river bank because the old, well worn structure was constructed to keep high water from entering into the canal uncontrollably. The replacement will provide the same protection, should handle even greater flow and pressure from the river, and should last indefinitely, all while providing a somewhat more ecologically sound and aesthetically pleasing area adjacent to the Big Wood River.

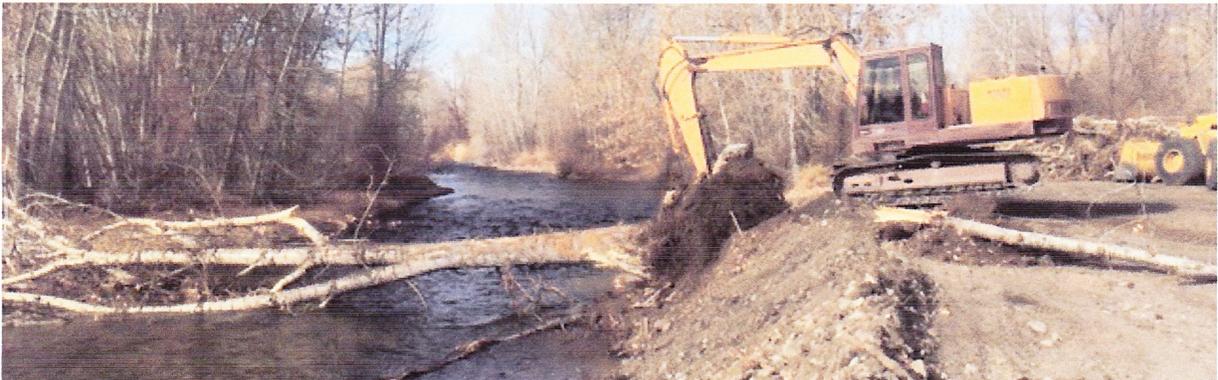
Pulling with all his might. Note the back end of the excavator off the ground as Keith pulled the last tree up the bank and out of the way. The roots of the trees, along with 20 foot lengths of the trunk attached, were buried back into the banks to provide very well anchored and solid interference for high velocity, highly erosive current.

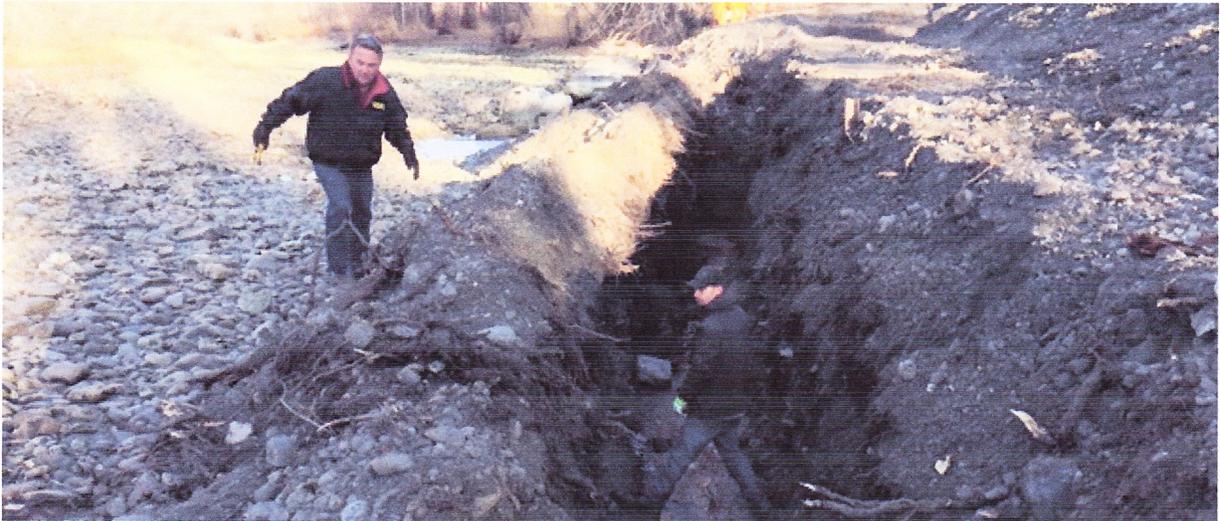
Embedding large rocks below the river bed to prevent any water from undermining the bank. The eastern bank of the river had been dried up by building a gravel bar up stream, to direct all flow towards the west side of the river.

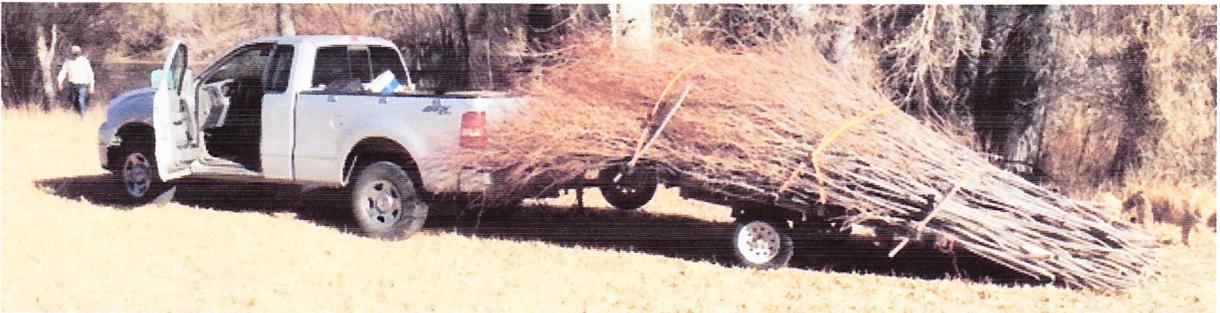
Gathering willow cuttings The cuttings were planted thru ought the project, in order to provide soil stability.

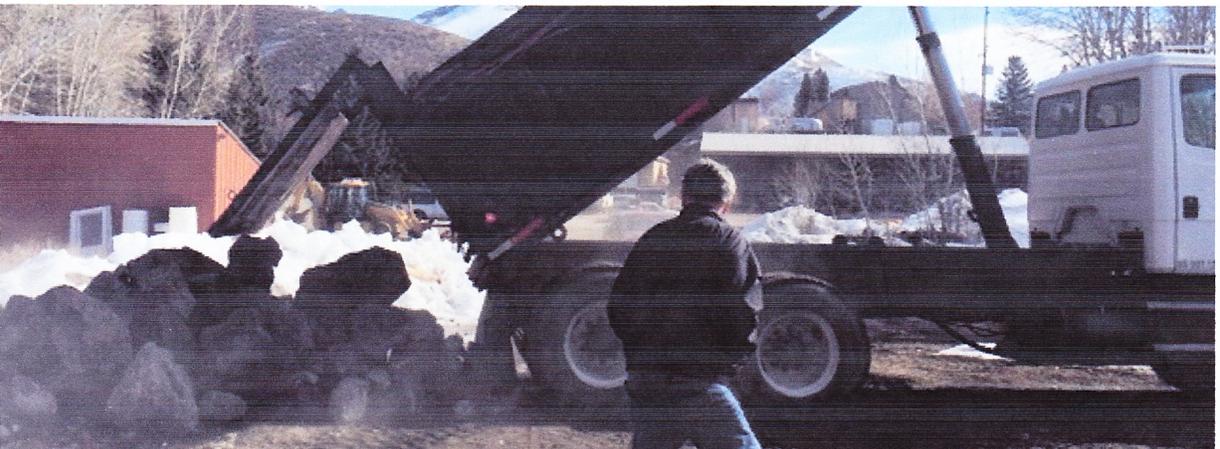
Rock hauled in It was placed deep under the bank and also up the slope to ensure stability of the embedded logs, roots, and willow bundles.

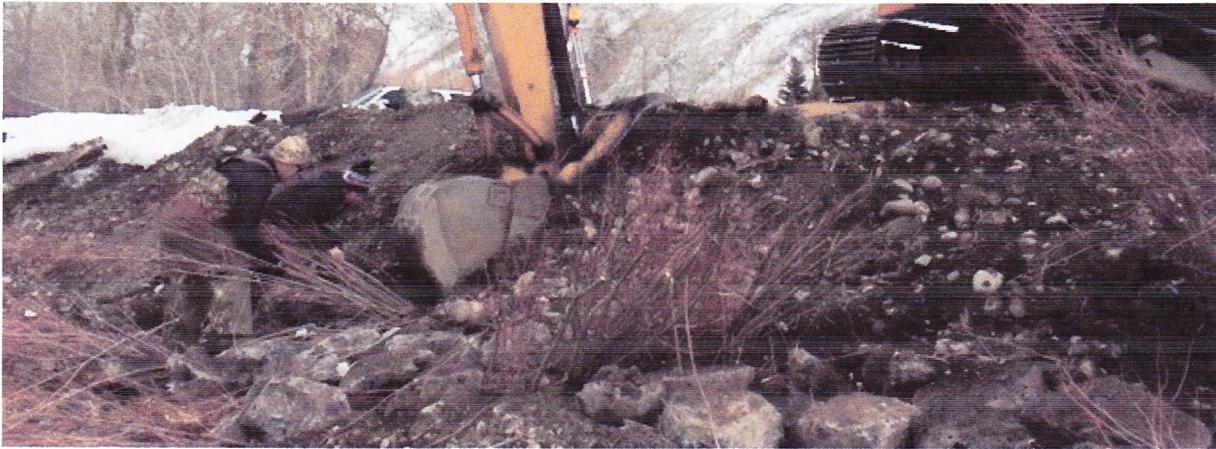
Planting willowsdeep into the bank to ensure that their planted end could be in contact with water below the surface, through the Spring and summer. We had very hardy, dedicated help from Trout Unlimited, throughout the whole process.

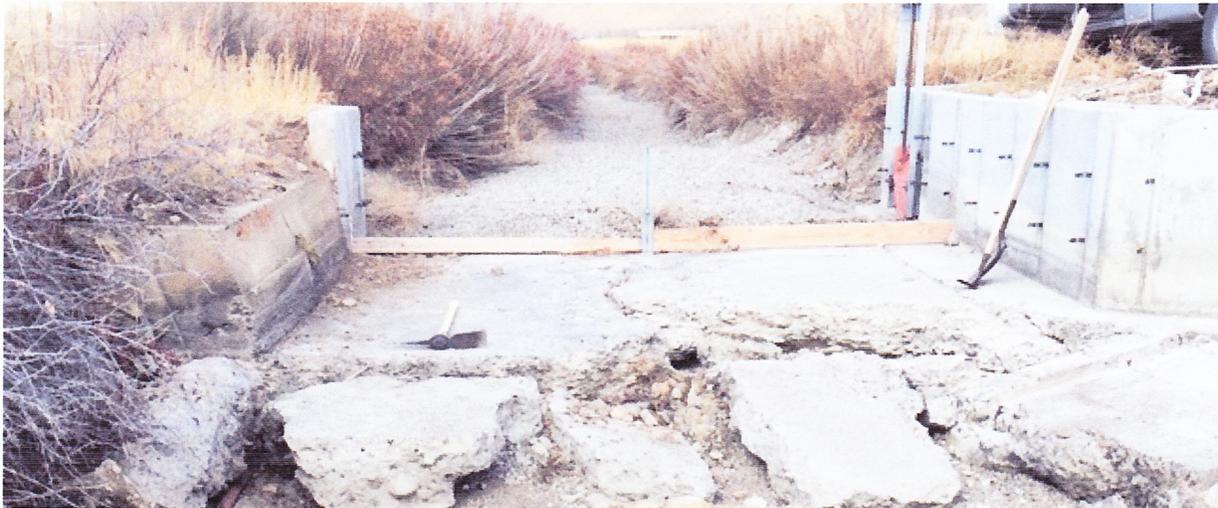
In the meantime: we tackled some of the more deteriorated portions of the canal infrastructure. The old floor, here is possibly around a hundred years old. In this case, there is a more recent wall on the left, and now a brand new wall on the right, put in by one of our water users along Kingsbury. Allowing these places to erode excessively would lead to unnecessary instability progressing up the canal bottom, and become increasingly difficult to repair.

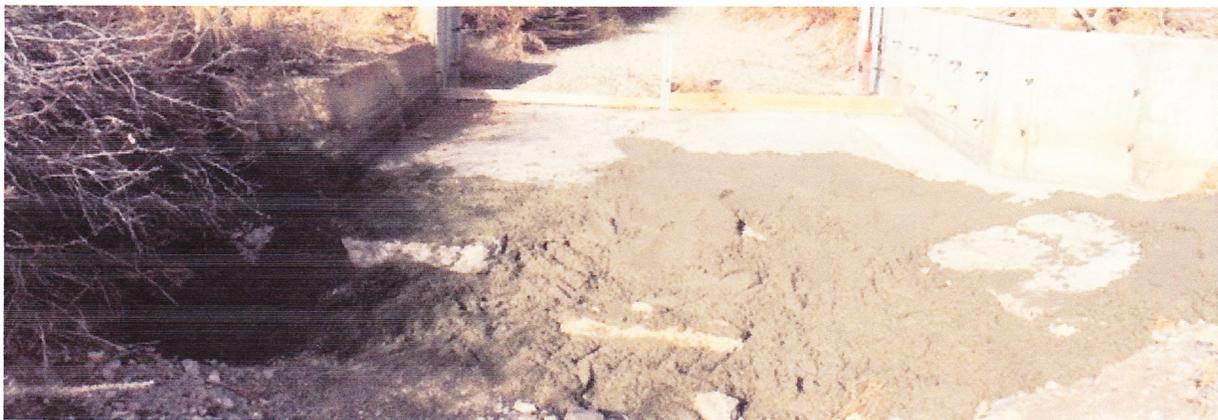
We did 6 of these ...rough but adequate repairs for a little over \$200.00 each, whereas waiting until the entire structure came apart would cost at least \$3-4,000, to rebuild just the smaller ones. We will continue to work on these.
