Ditch Doings Nov 16, 2018

It's been a beautiful Fall, and a busy one! It's not over yet, but Winter is in the Forecast; snow in a week!

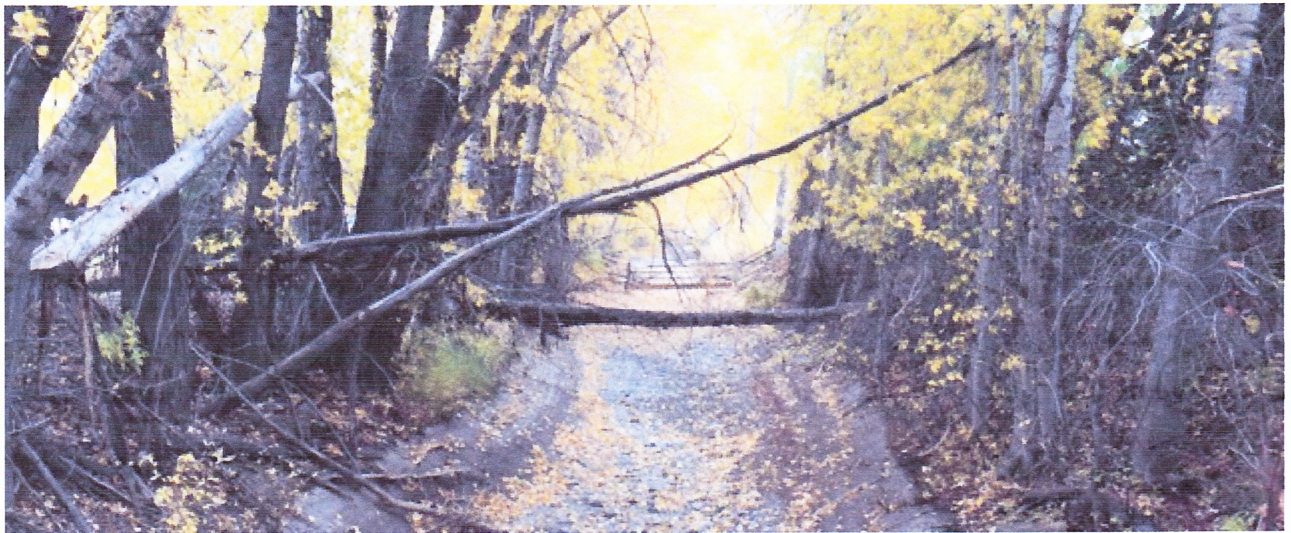
Upper Canal issues, soon to be addressed

For now: besides having snow in the forecast, Alpine Tree Service is scheduled to begin some removal of large trees, which are posing the most risk, over the Upper Canal. This work has been post-poned twice already, once due to rain about a month ago. Keith still has a couple of stretches of ROW to clean up, especially along the long-put-off sections of the East Lateral. Though all the large Cottonwoods were cut down 10 years ago, on that section, the old remnants of them are still present, along with other after-effects of that work, like broken down fences and old concrete diversions.

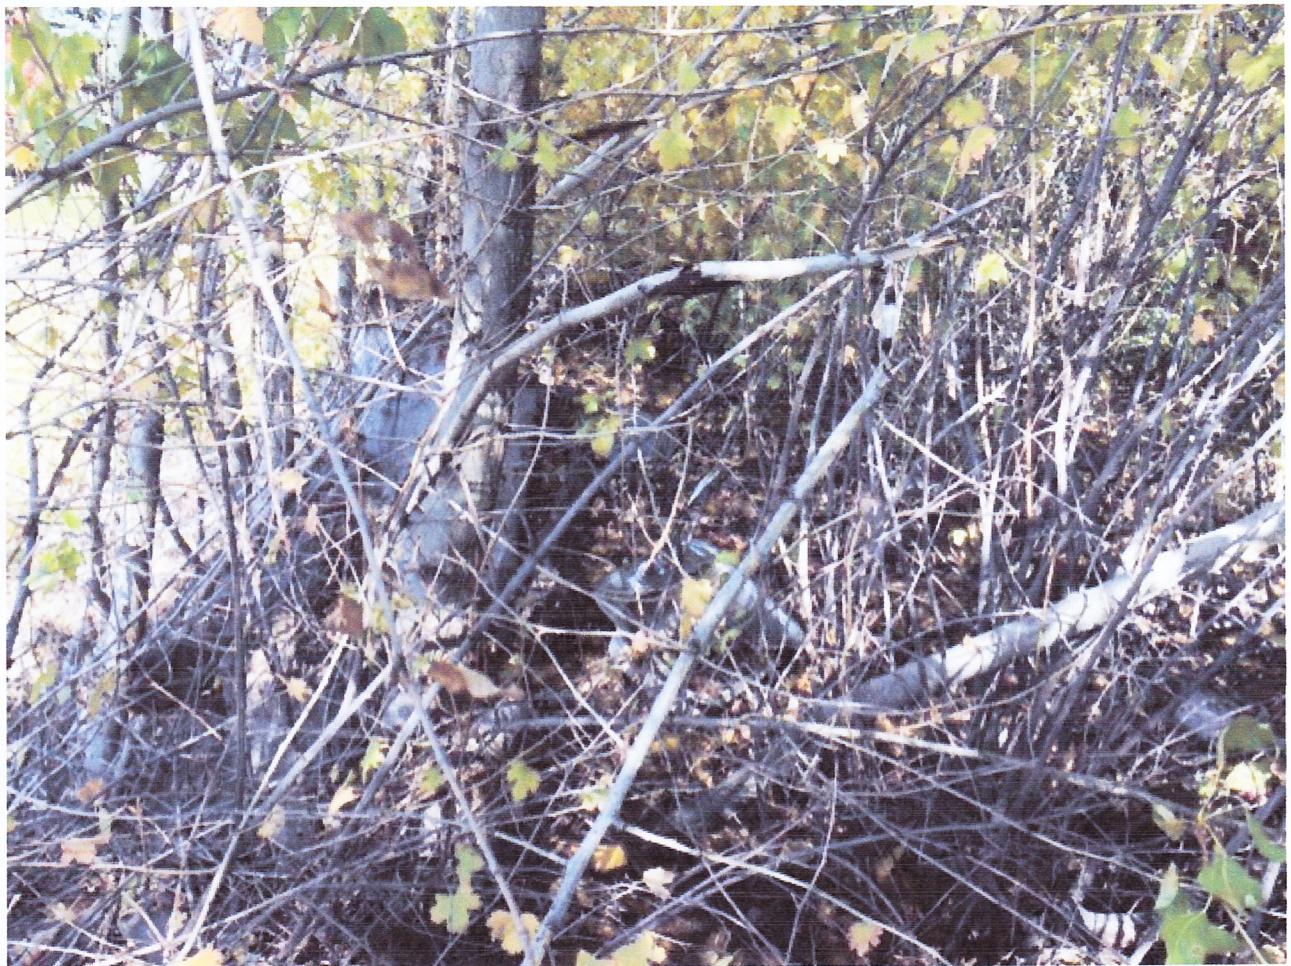
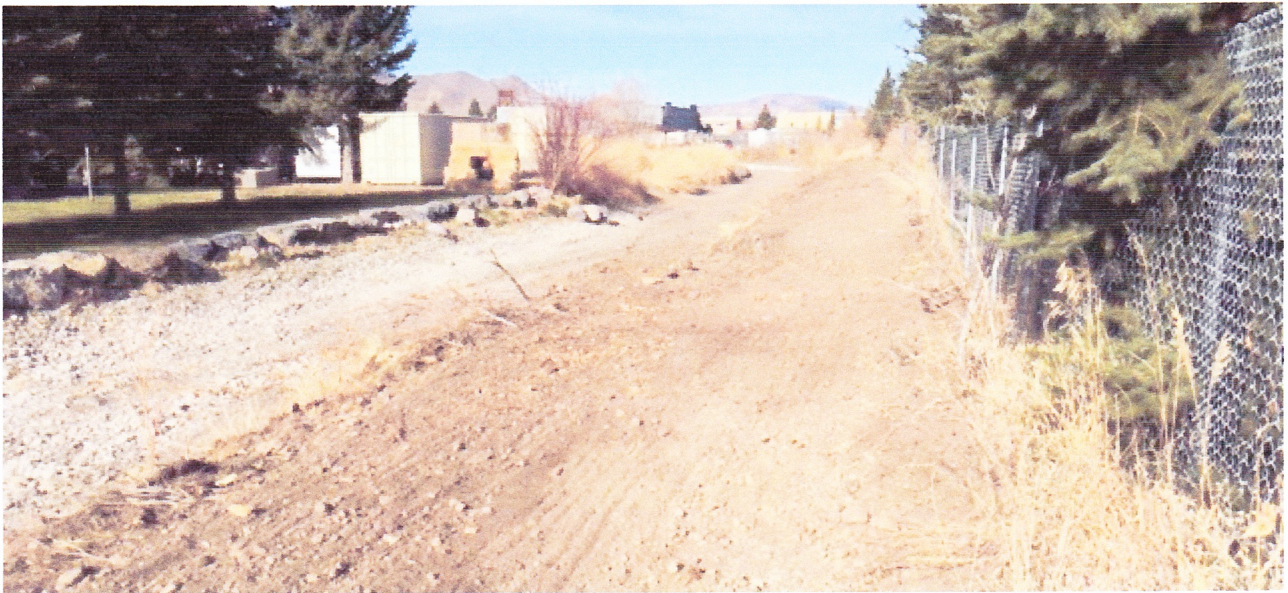
The first foto is what Doug Neidrich used to see from his kitchen window. The second foto, from the same location, shows evidence of a little work. I'm not certain he likes the new scenery but I assured him we weren't done. The fence gets a regular watering from the neighboring yard so Justin planted grass along our ROW, and I threw a ton of Hollyhock seeds along the fence. Stay tuned, Doug.

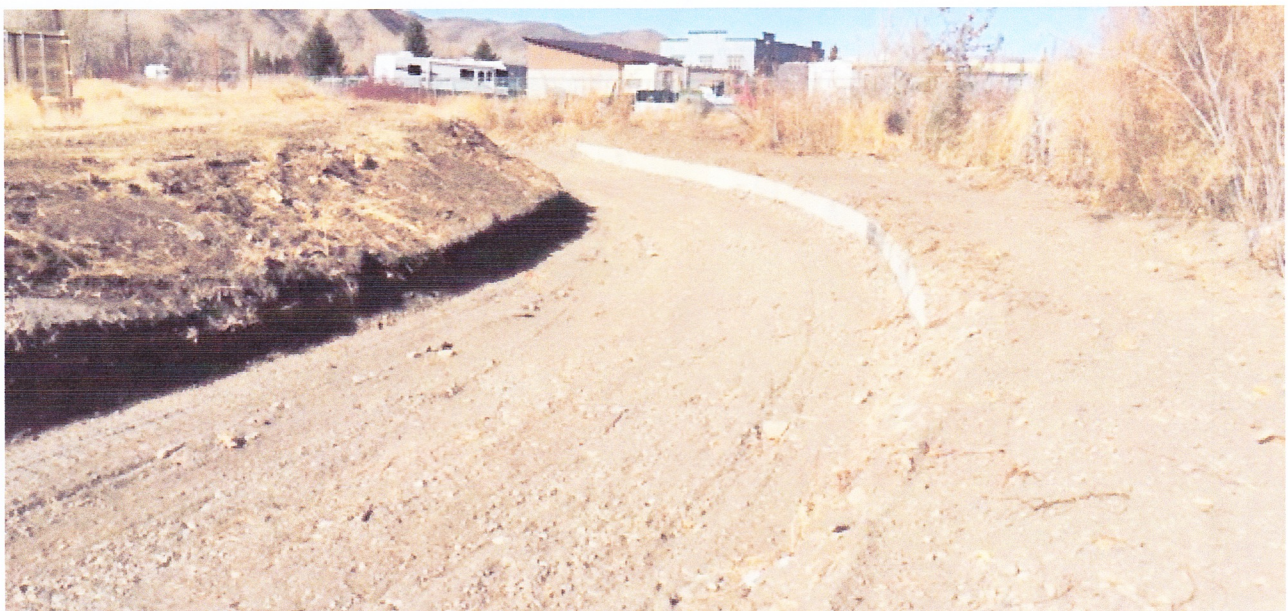
Looking up the Canal, across from the fire station. Large trees used to provide some bank stability around this turn. After the trees were removed, the high fast current along this stretch was eroding into the neighboring yard. We placed 27 two ton blocks along the foot of the bank thru-out the turn.

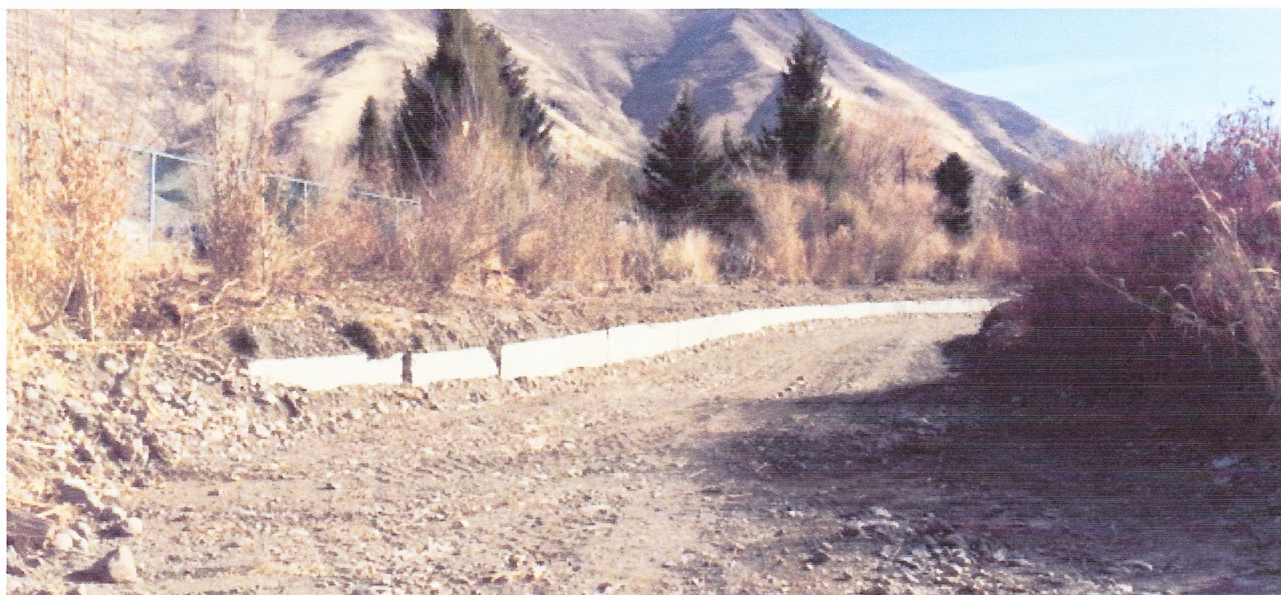
Same turn looking down stream. I've left what will become a small grove of trees at both the upper and lower ends of the wall so that tree roots will serve to protect the bank where the wall starts and ends, in an attempt to benefit from a little bit of holism. Don't anyone get carried away and spray to kill them again, as any water getting behind the blocks could quickly render our work worthless.

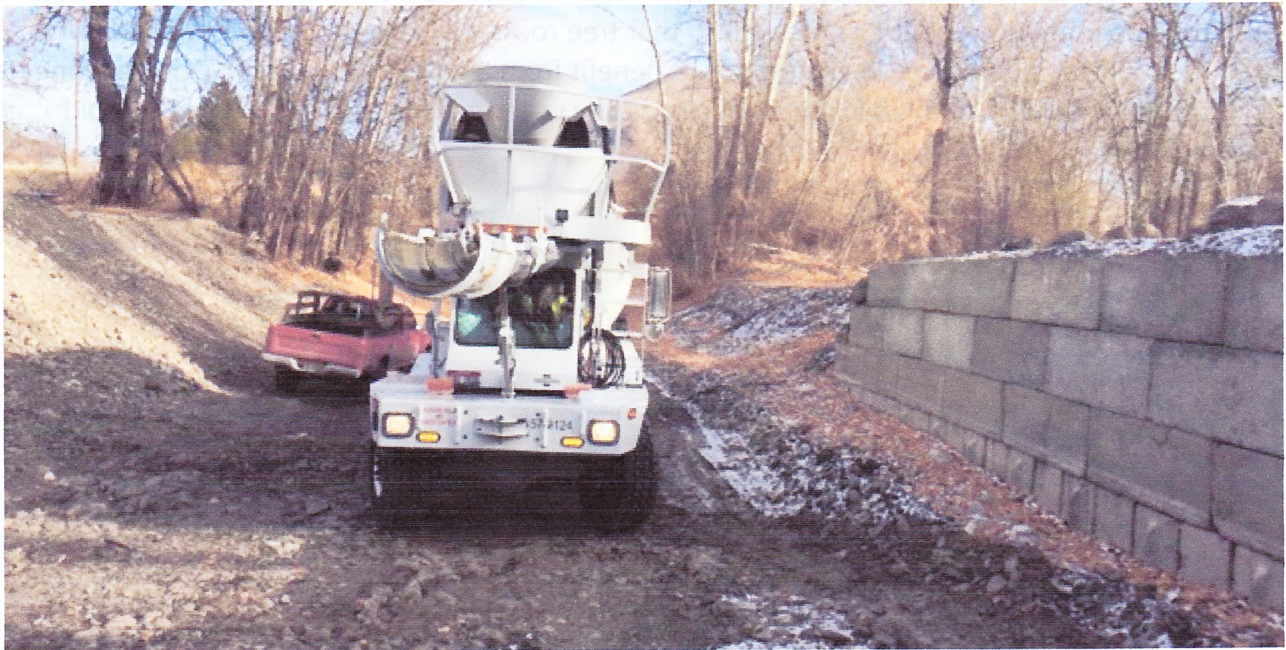
For the 2nd year in a row we have coaxed these monsters into the top of the canal. It's impressive to see how these things handle getting off road. The work on the eroded bottoms of the Main Gates is done, for now. We will be monitoring it for years, hopefully, to see if our work of the past two Falls, can endure the beatings from the high spring flows as well as the original work did. Stay tuned.
